R
E
H
O
B
O
T
H

B
L
O
C
K

B

CLIENT INFORMATION

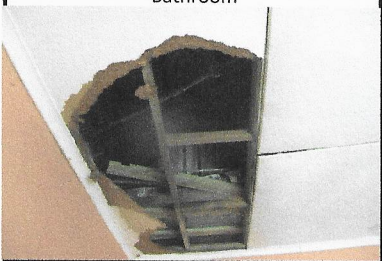
Broken ceiling boards

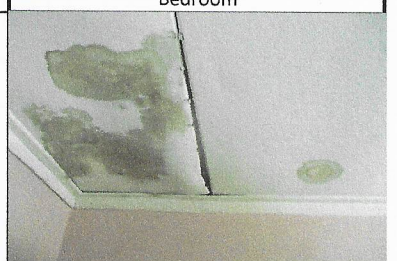
Roof leaks
