R
E
H
O
B
O
T
H
B
L
O
C
K
B

Erf Number	11	Town / Suburb	REHOBOTH BLOCK B
Property Street Address	CHURCH STREET		
Project name (if Sectional Title)			
Purchase Price		Date of Purchase	
Stand size	1425m ²	Special Design Foundations Required	
Type of property	<input checked="" type="checkbox"/> Single Residential <input type="checkbox"/> Townhouse <input type="checkbox"/> Flat <input type="checkbox"/> Vacant land

VALUATION CONSIDERATION : RESIDENTIAL

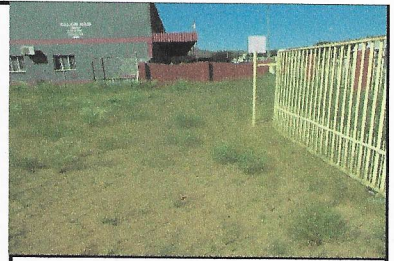
PHOTO PORTFOLIO

The property is located along Church Street. The street has numerous business properties such as FNB offices, Bank Windhoek, Woerman Brock, Pep Stores, carwashes and some retail shops. The erf is zoned Business, but however, it has been improved with a residential dwelling. General wear & tear of the property was evident. The property was however only inspected externally, and as observed from the previously done valuation dated: 30/1/2020; the dwelling has no ceiling, no kitchen BIC, no bedroom BIC and is only partly fitted with floor covering.
